Overwash observations on a Dutch barrier island

Anita Engelstad¹, Maarten van der Vegt¹ and Piet Hoekstra¹

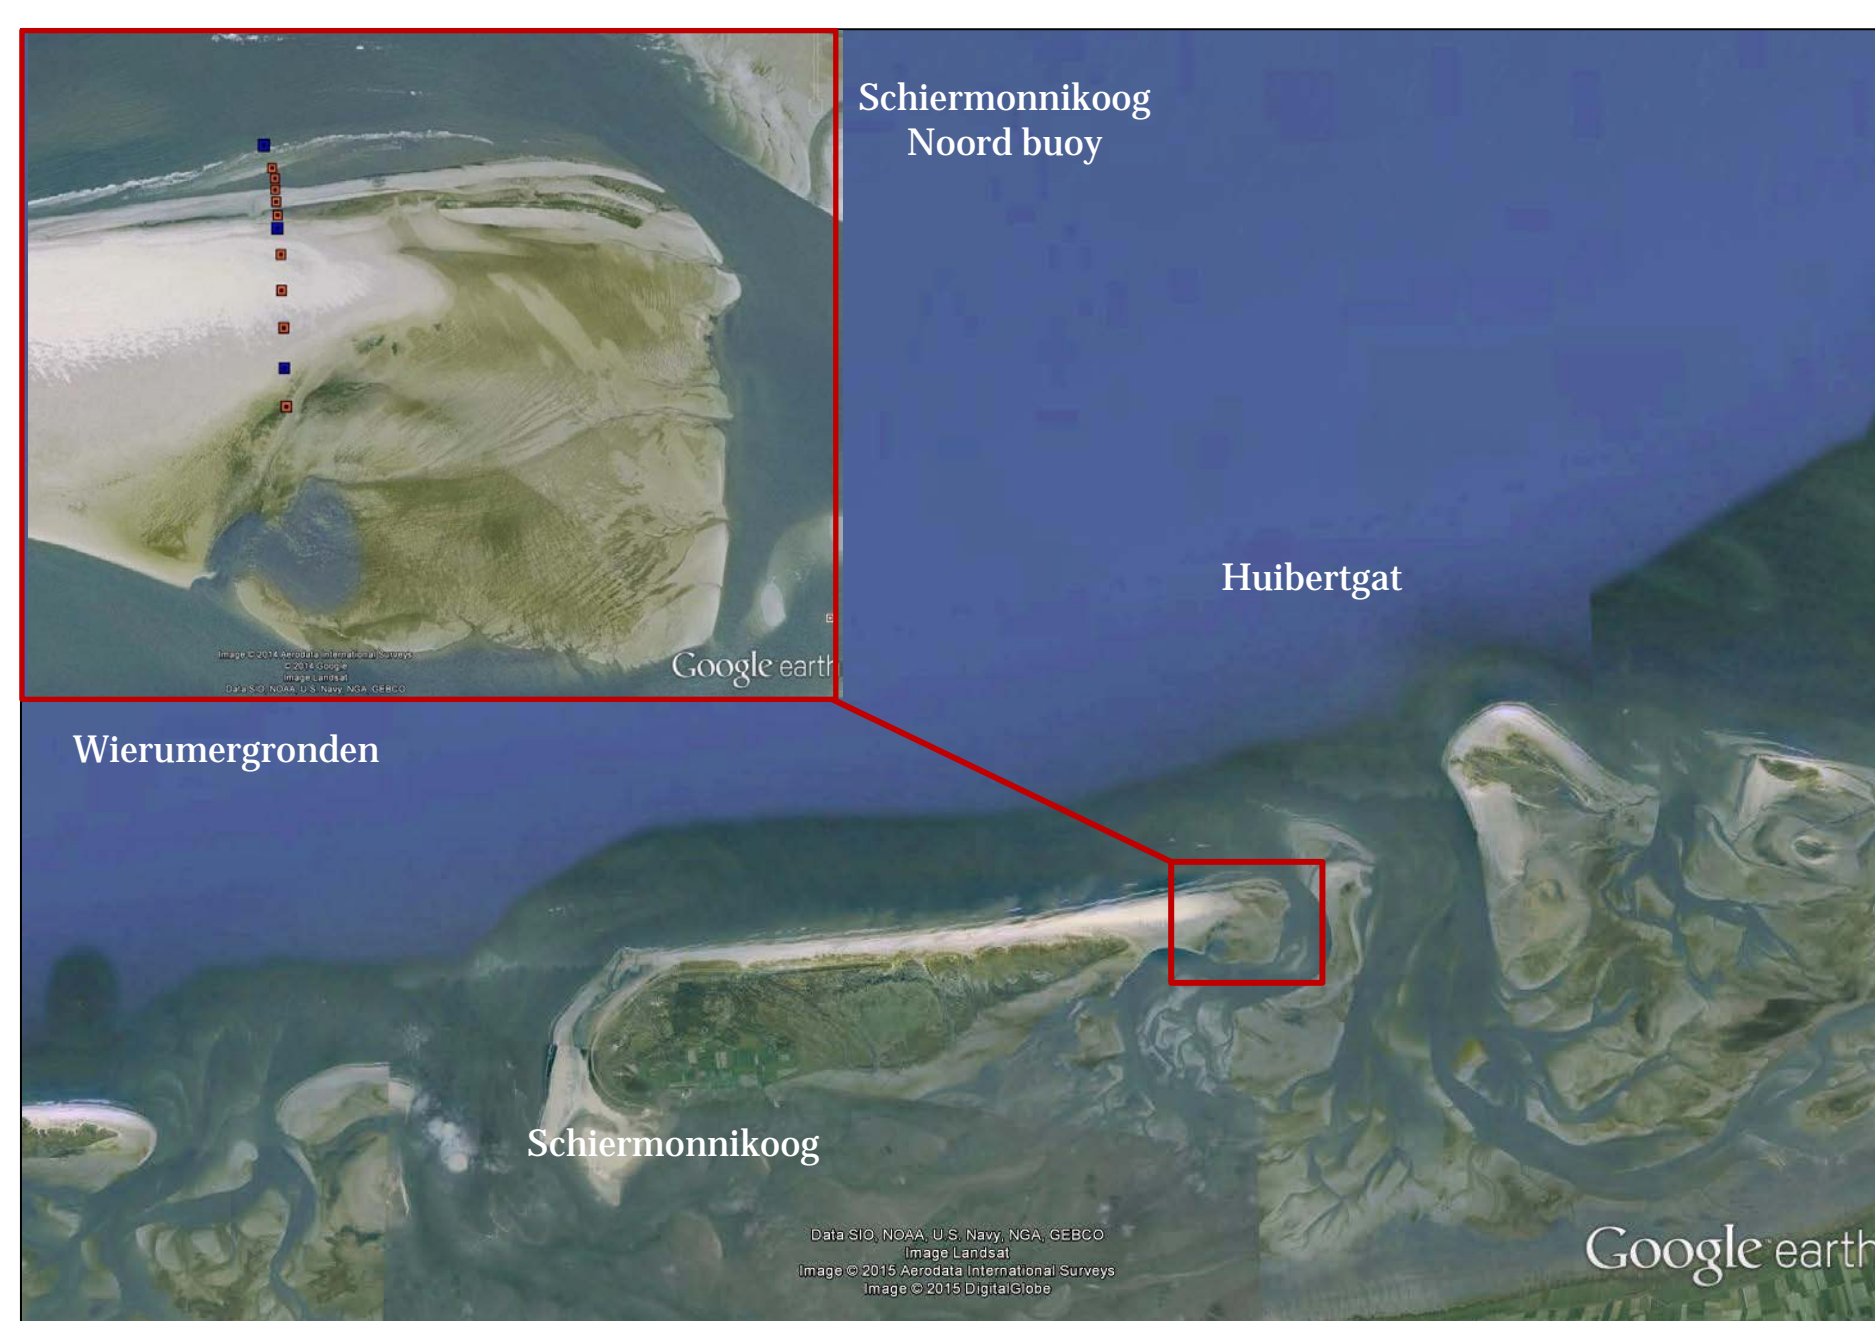
Figure 1. The field site is located on the Dutch barrier island of Schiermonnikoog. Approximate locations for available wave - and water level data (RWS) are indicated. The instrument locations of ADVs (blue squares) and pressure sensors (orange squares) are shown in the inset.

From November 2014 until the end of January 2015, ten pressure sensors, three acoustic doppler velocimeter (ADV) and three optical backscatter sensors were deployed on the low-lying (max height $\sim 1.70\text{m}$, relative to NAP) eastern end of the Dutch barrier island Schiermonnikoog. Here, only results from the pressure sensors are shown.

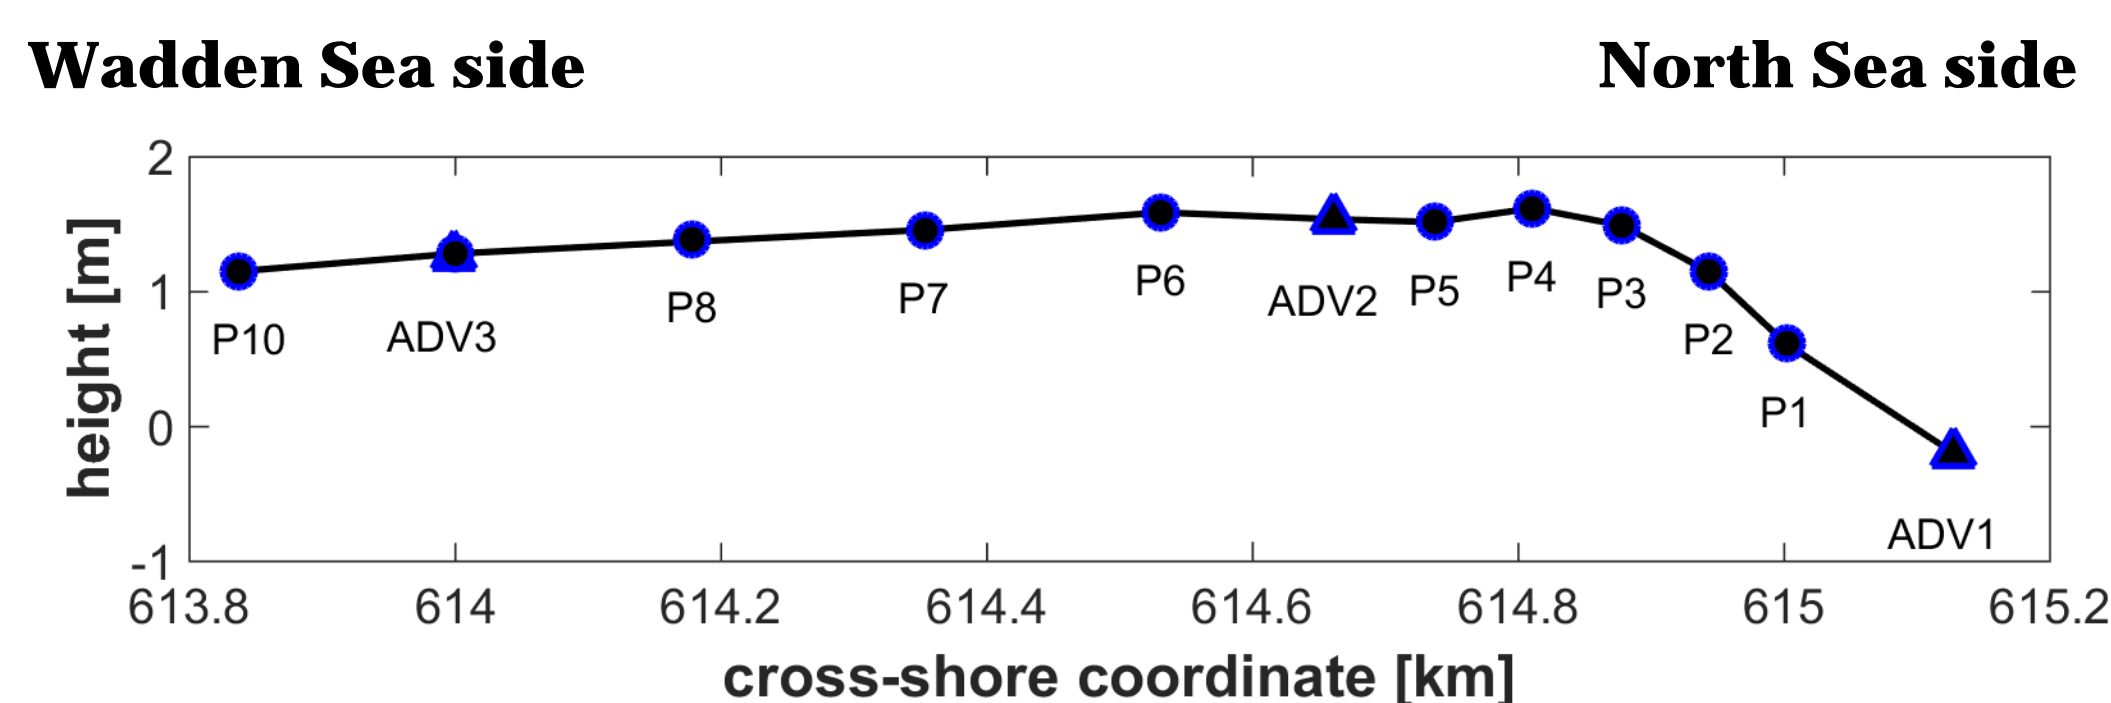
Figure 2. The cross-shore profile (black line) during deployment is shown with the Wadden Sea to the left and the North Sea to the right. Blue triangles show the ADV frames and blue circles the pressure sensors.

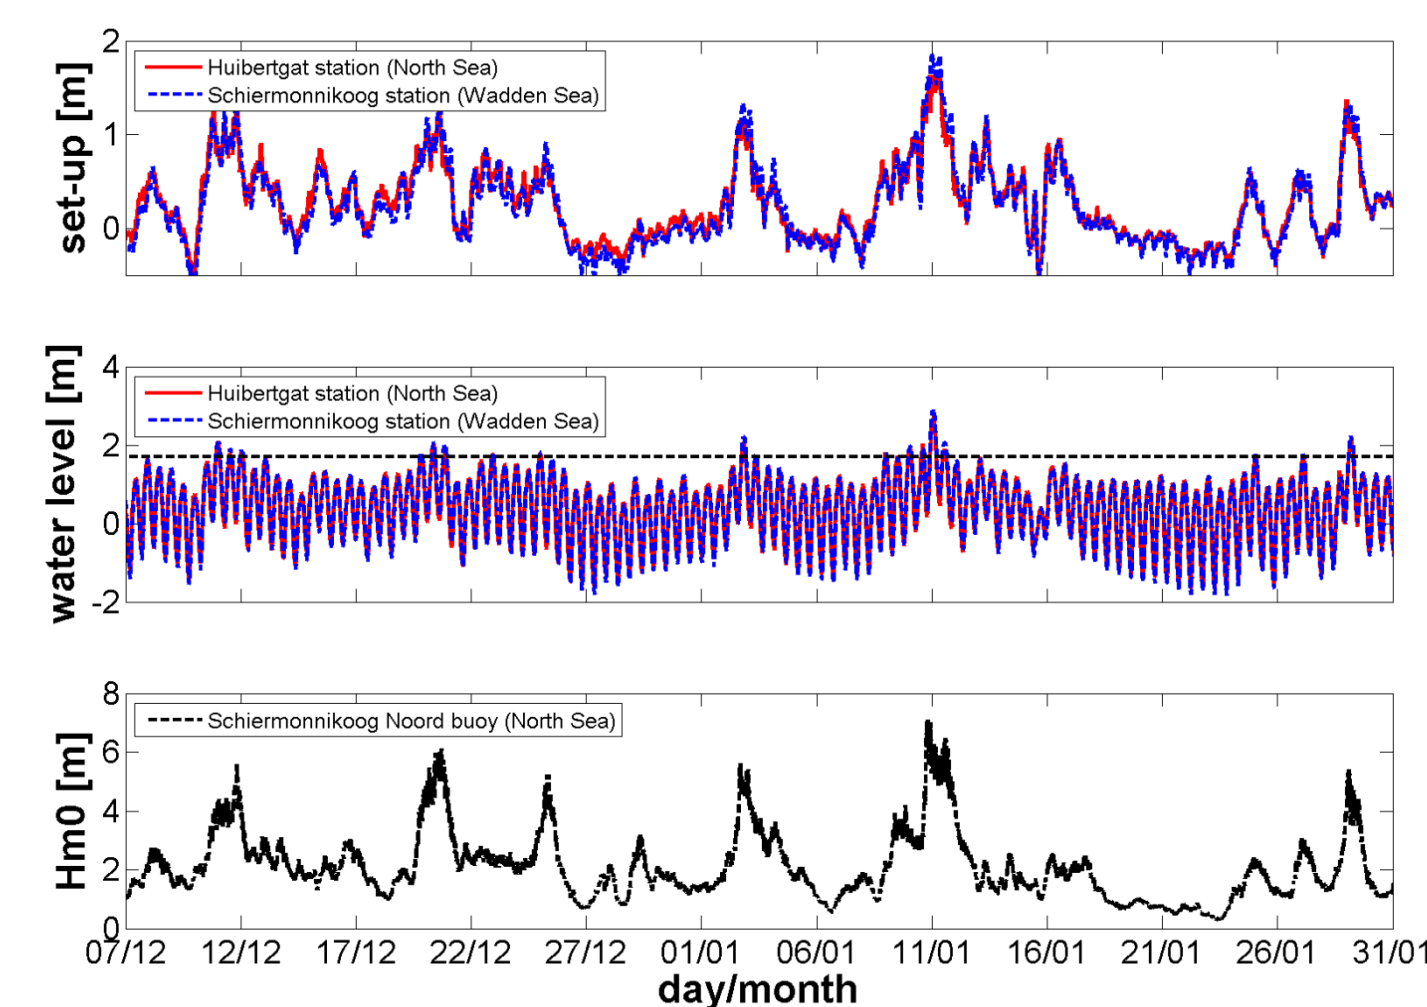
Figure 3. Set-up (a.) and water level variations (b.) for the Huijbertgat station and the Schiermonnikoog station (see figure 1 for location) and significant wave heights (c.) at the Schiermonnikoog Noord buoy. The dashed line shows the critical level when the island will be flooded.

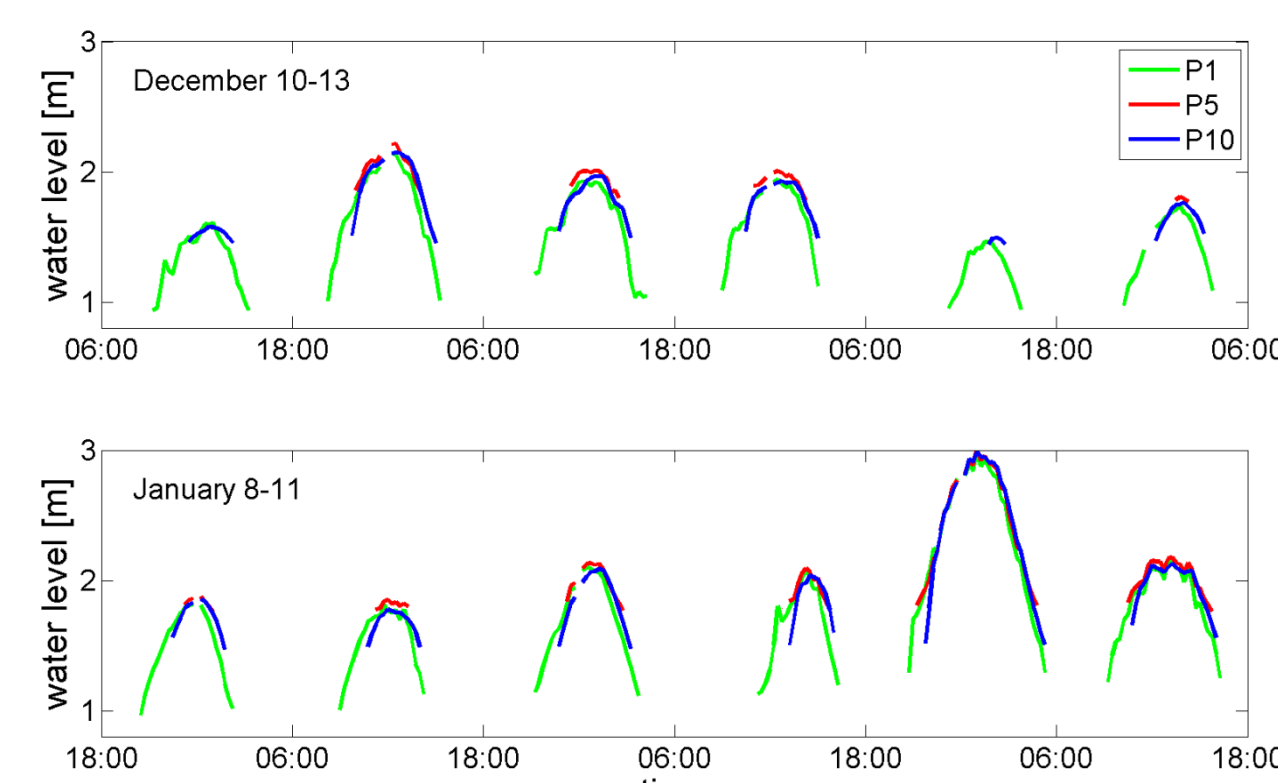
Figure 5. Water level variations over time across the island for two overwash occasions: December 10, 2014 (a.) and January 11, 2015 (b.). The data is averaged over 15 minutes.

- Water levels are fluctuating across the island with time and tidal stage. The effect of wave set-up, which might drive strong cross-shore flows (see poster of D. Wesselman), is visible in the observations.
- Low frequency wave heights typically decrease as waves propagate across the island.
- High frequency waves show frequently increases after initial dissipation.

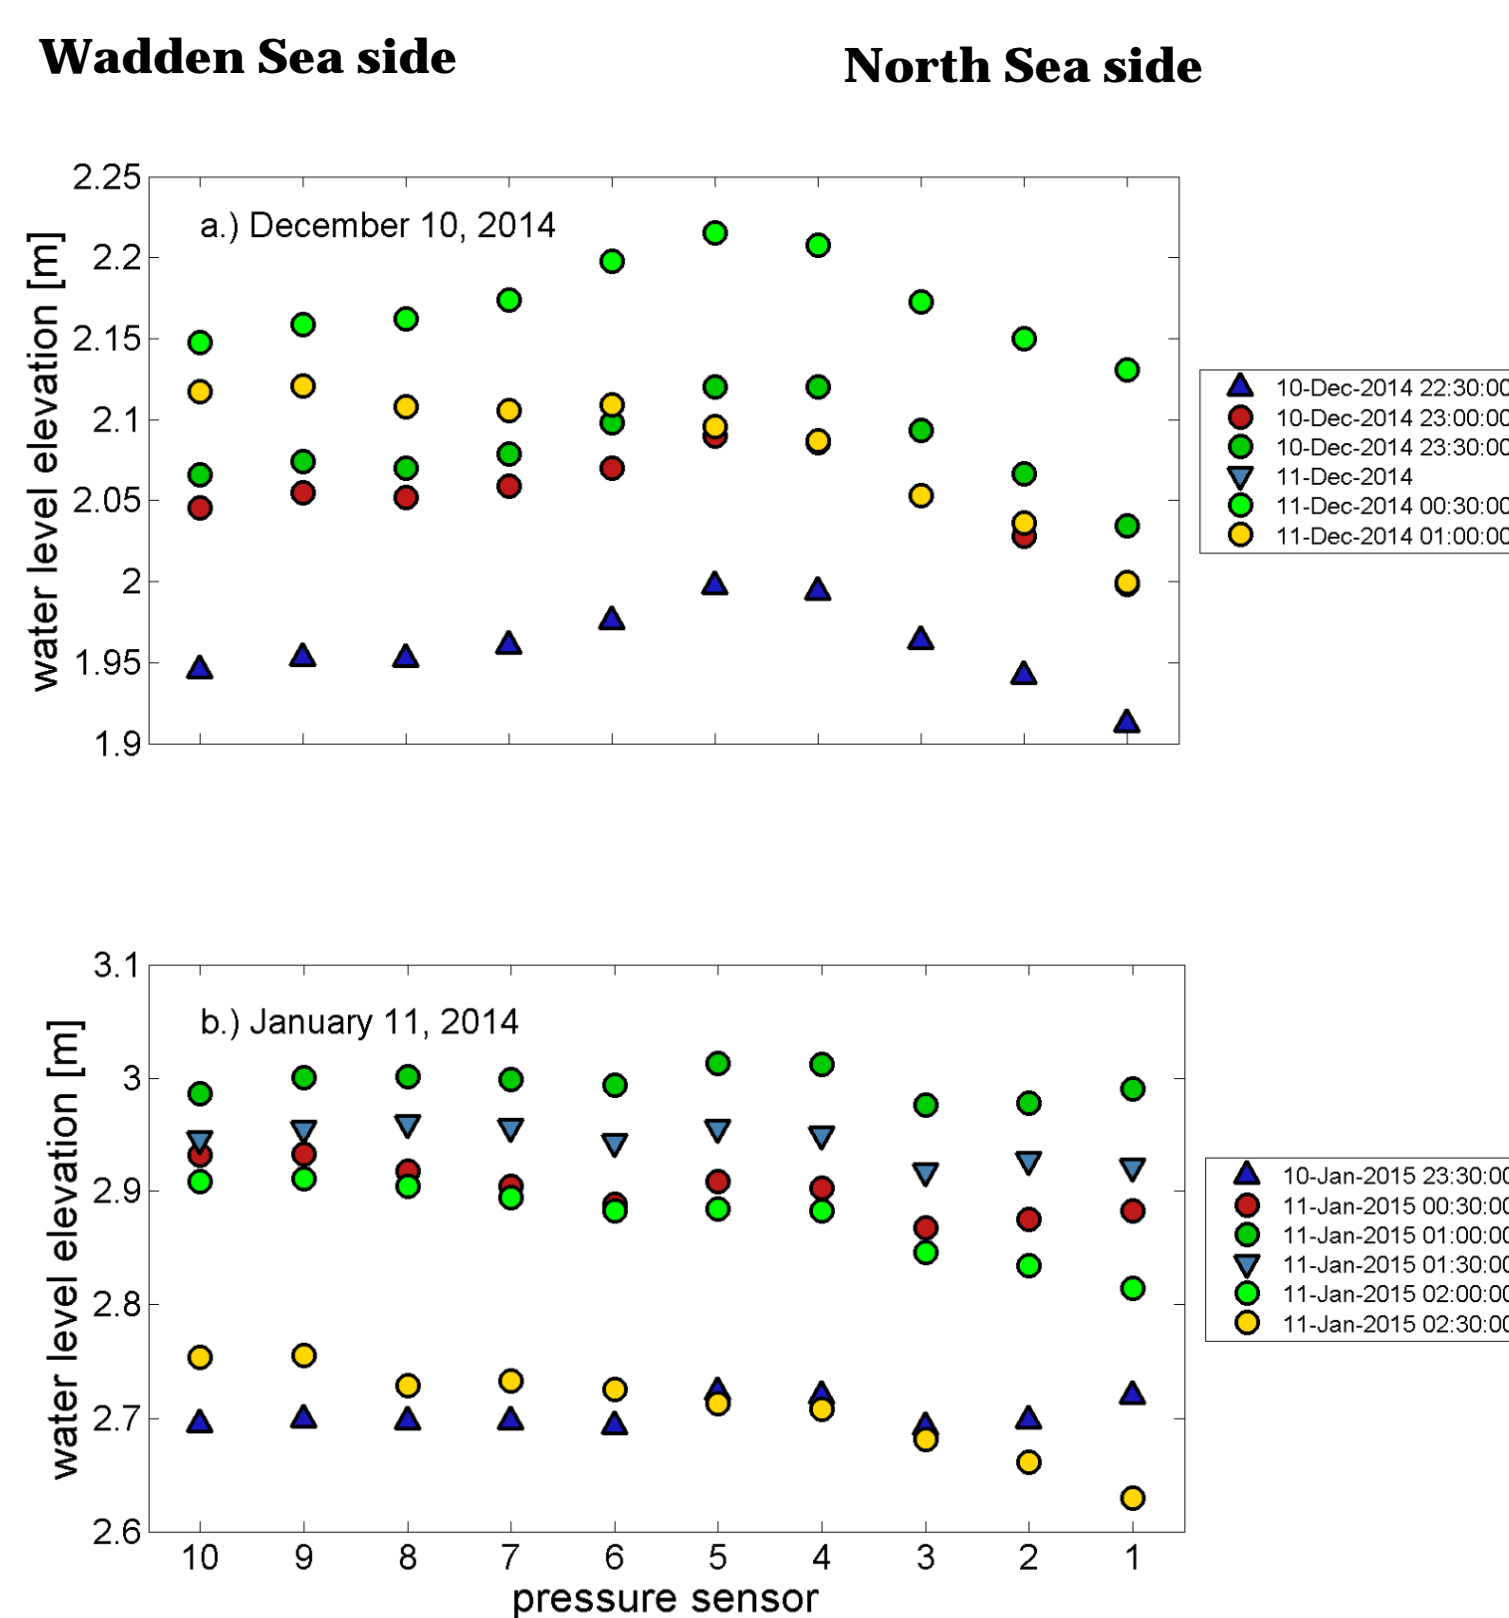
Figure 7. Water levels across the island during two overwash occasions: December 10, 2014 (a.) and January 11, 2015 (b.). The Wadden Sea is on the left hand side, the North Sea to the right. See legend for times. The data is averaged over 15 minutes.

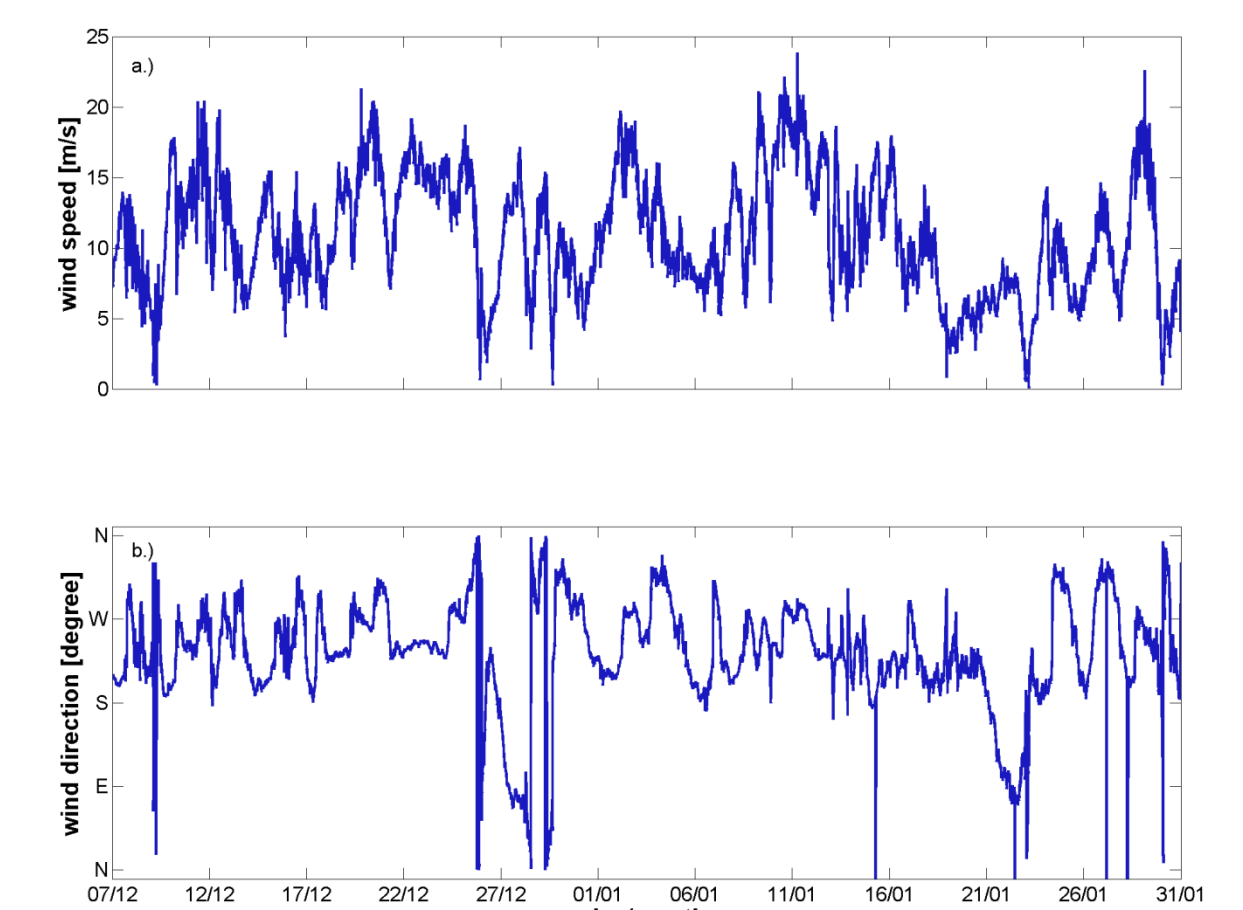
Figure 4. Wind speed (a.) and wind direction (b.) at Wierumergronden (see figure 1 for location).

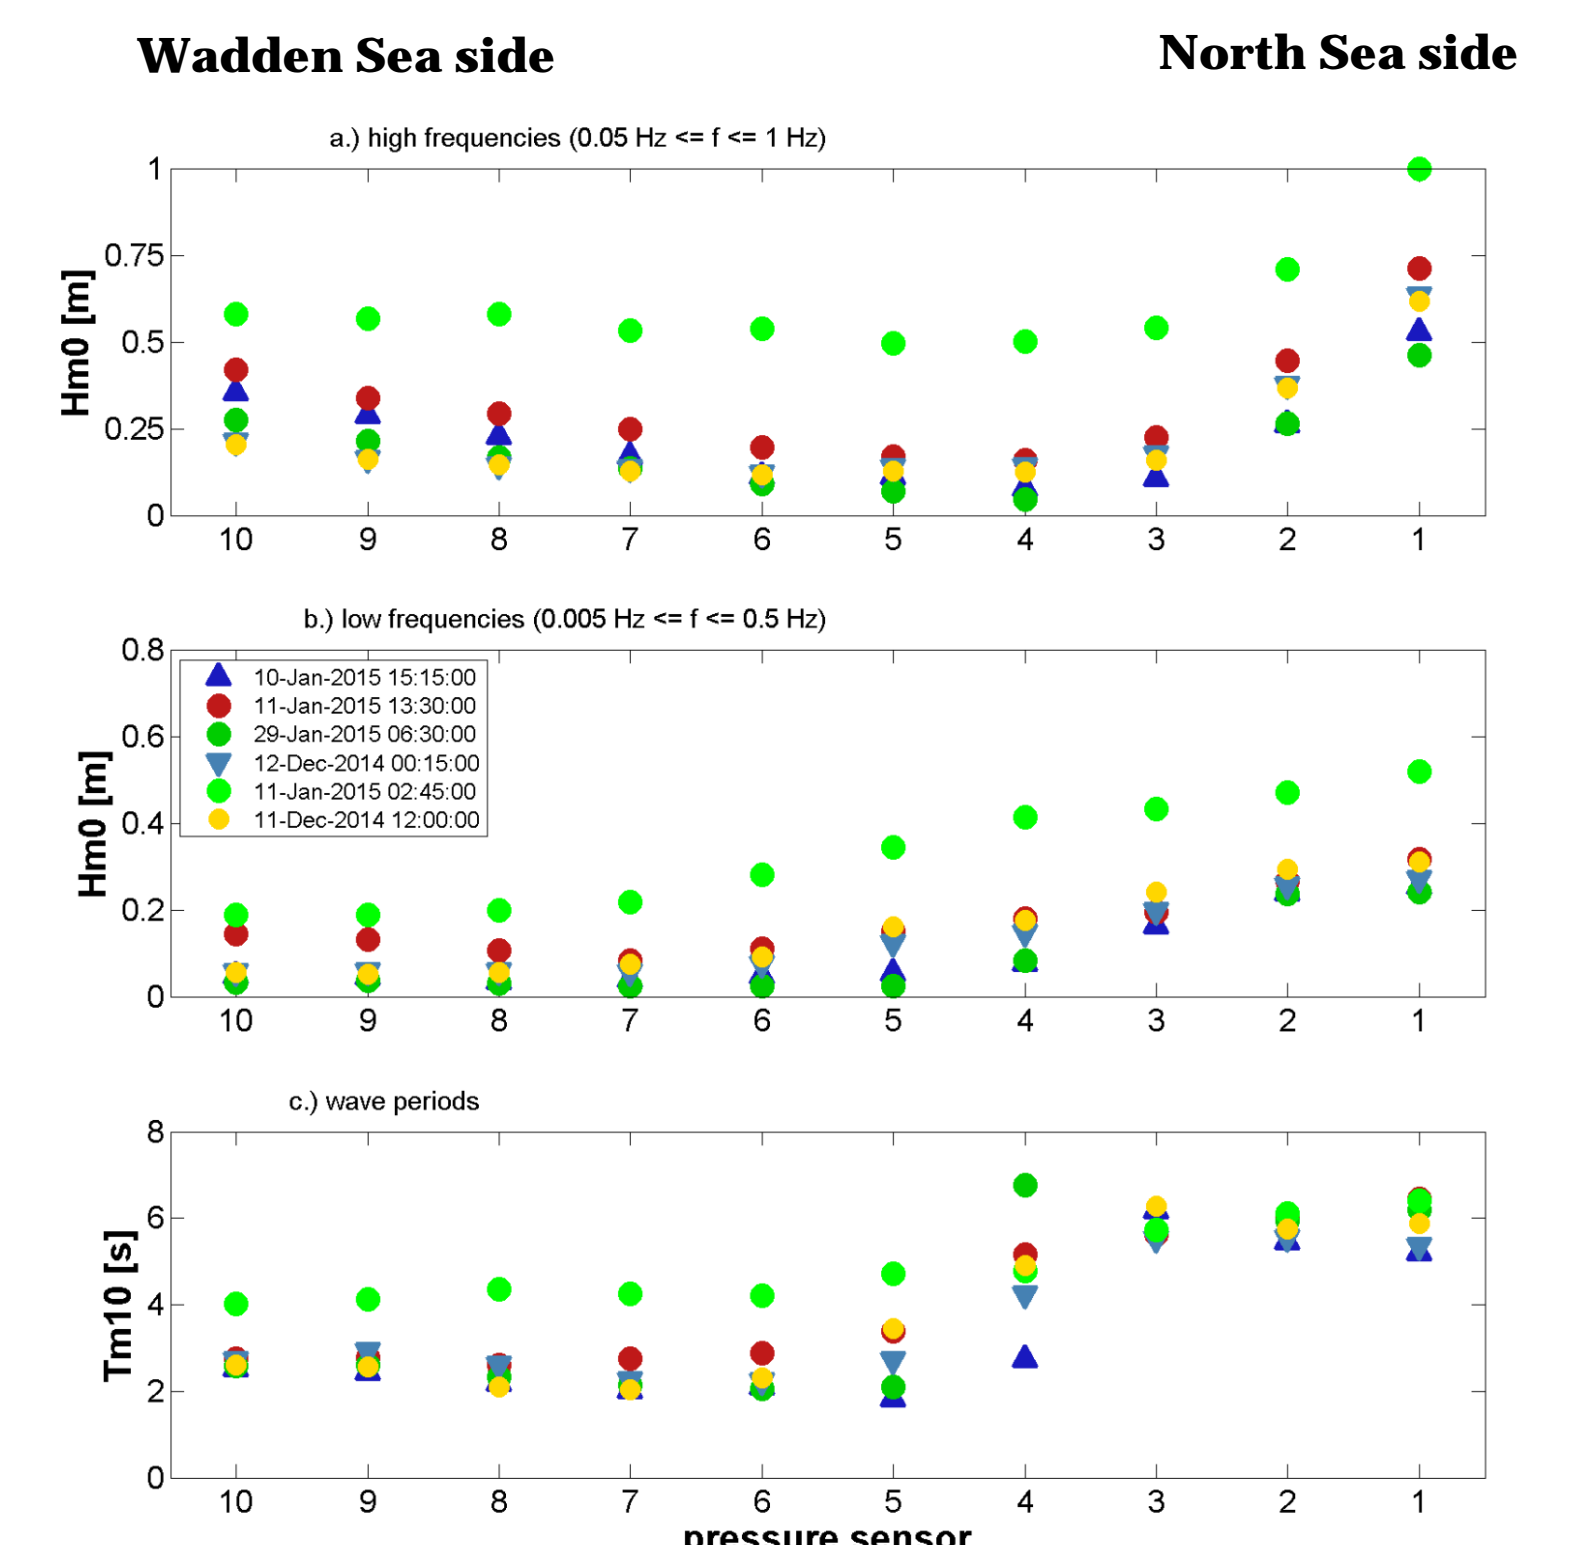
Figure 6 Wave heights across the island on different days (see legend) for a.) high frequency waves, b.) low frequency waves, and c.) wave periods. The data is averaged over 15 minutes.
