Mapping Bank Erosion and River Morphology of the Petit Buëch River in France using timeseries of UAV imagery

Steven M. de Jong, Sven Hemmelder, Wouter Marra, Henk Markies & Maarten Zeylmans Van Emmichoven
Faculty of Geosciences, Utrecht University NL

Abstract

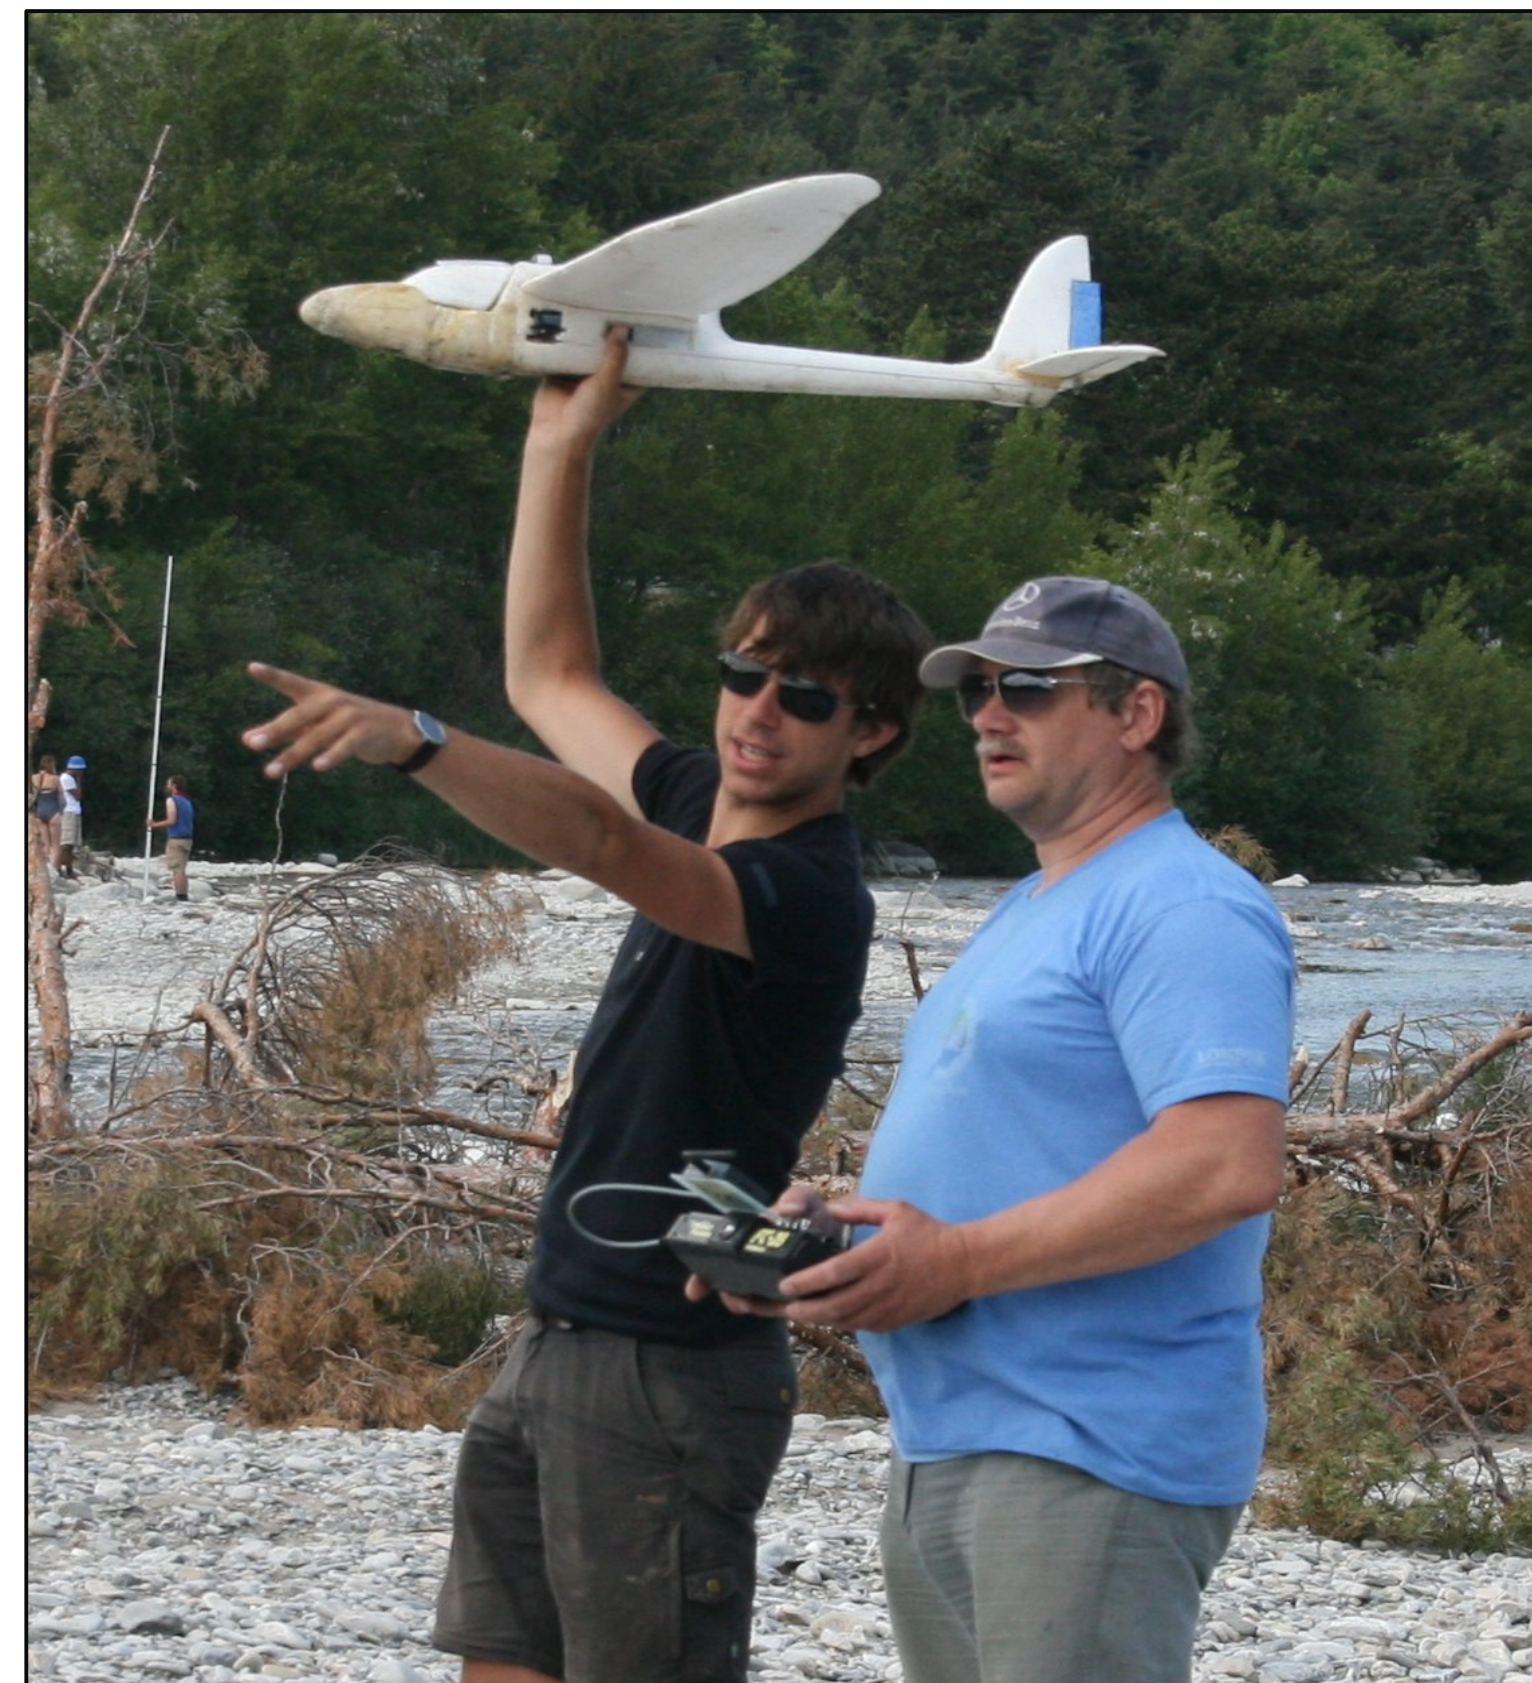
The Petit Buëch River in the Hautes Alpes (F)

This river has a catchment area of approximately 389 km². The source is located in the Dévoluy massif and river length is around 44.5 km. Land cover in the catchment is forest for 80% and agricultural land for 20%. Discharge is highly variable: mean daily discharge is 14 m³/s, and 2, 10, and 50-year daily flood discharges are estimated at 140, 250, and 350 m³/s.

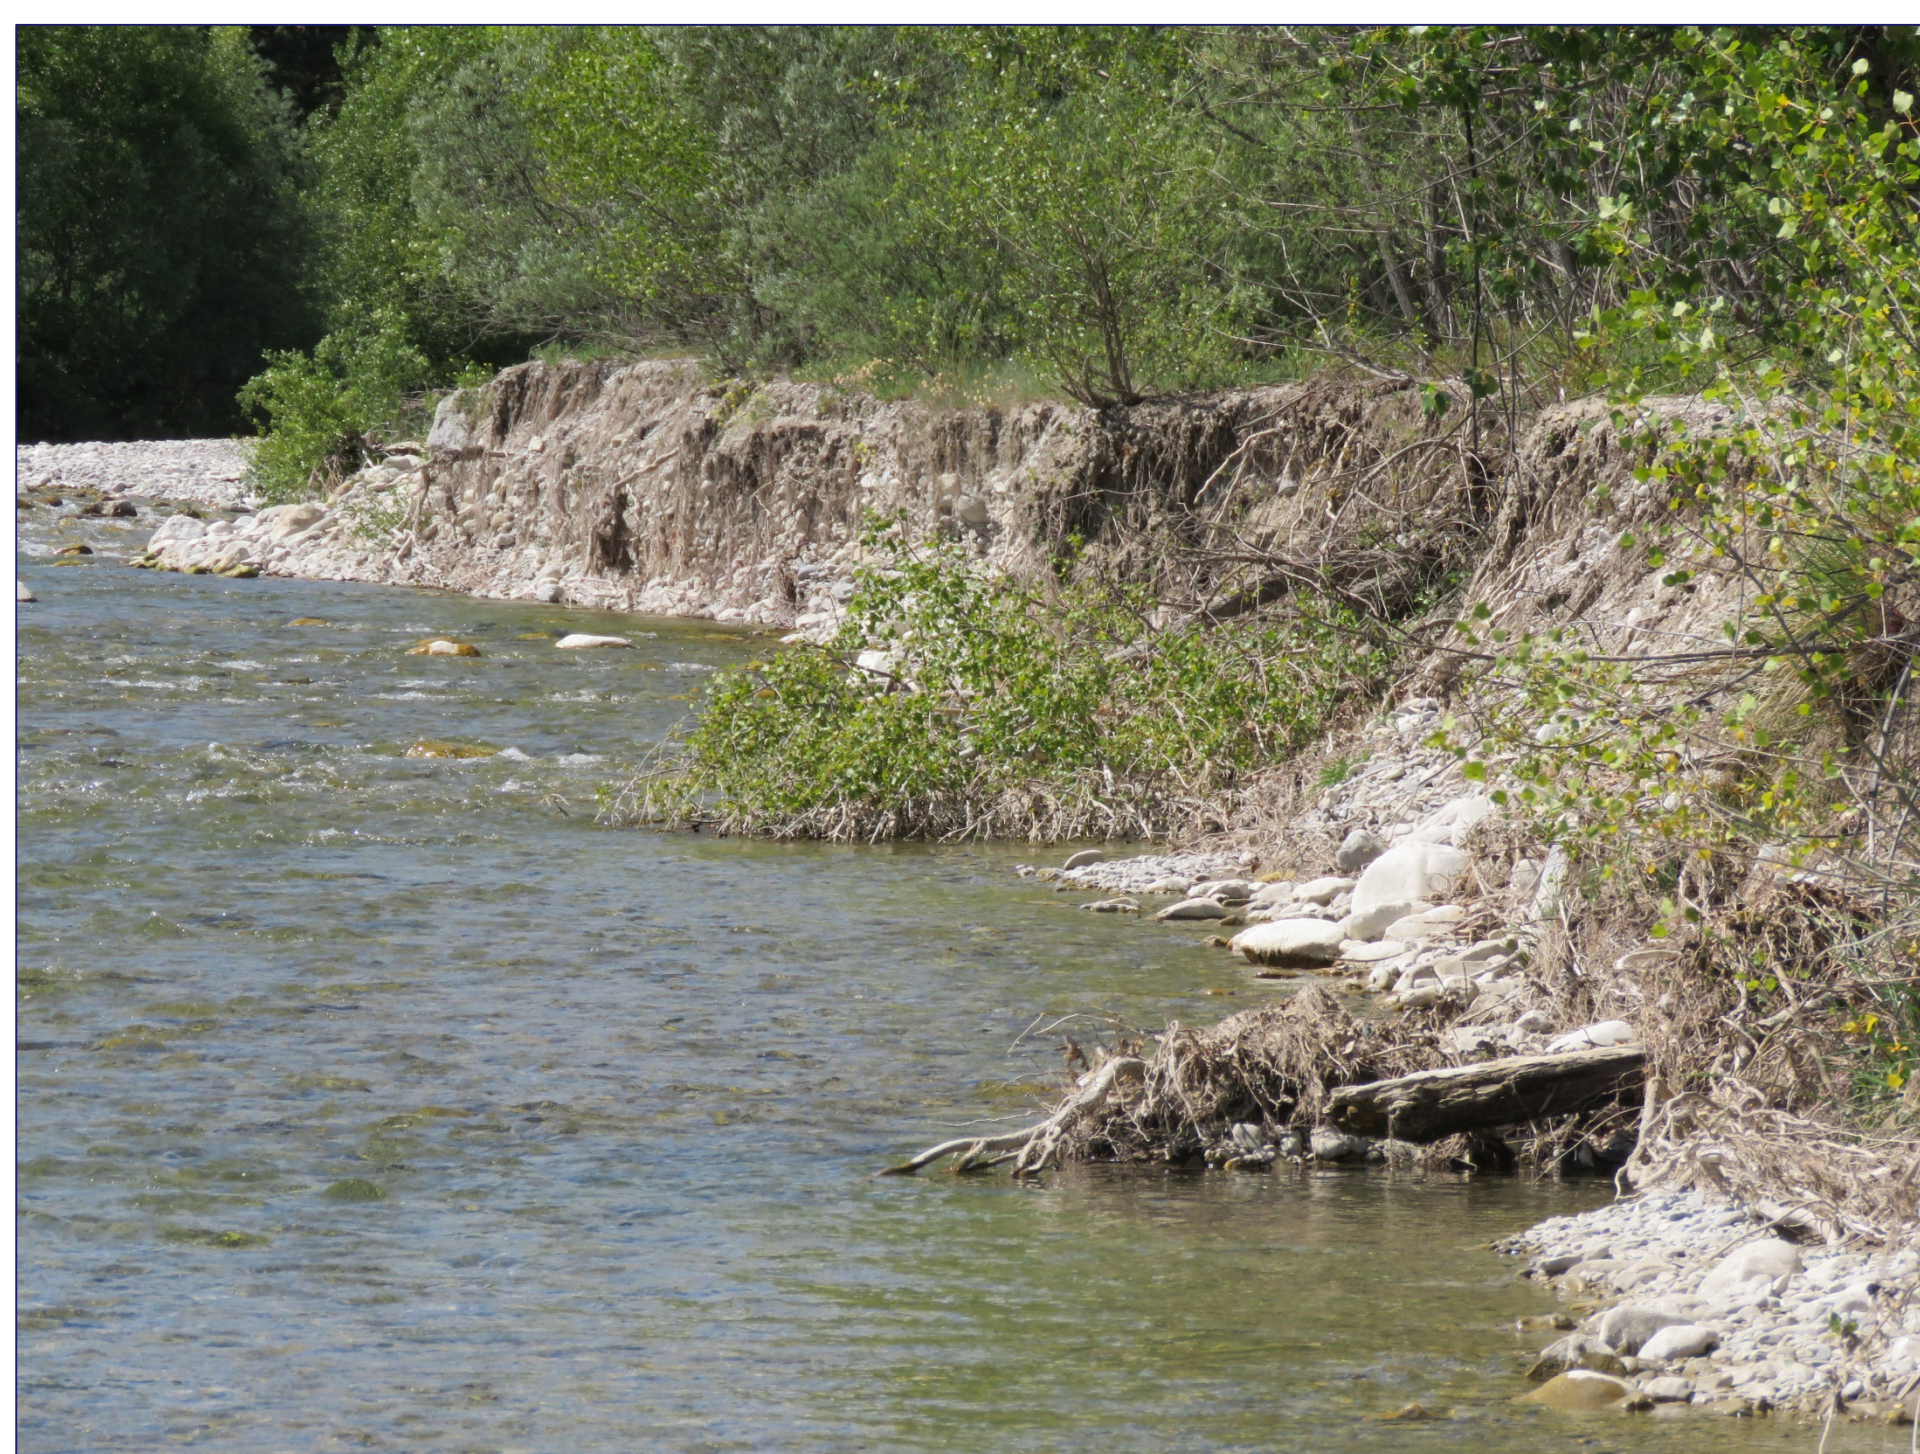
UAV used for image acquisition

A fixed-wing aircraft with manual control was used. The camera aboard was a Canon PowerShot D10 RGB compact camera with a resolution of 4000 by 3000 pixels and a focal length of 6.2 mm. The flight altitude was on average 130 m and was a trade-off between the size of the studied flood plain and the desired spatial detail of approximately 3 cm pixels.

One battery set allows approximately 10 minutes of flying. Per river section we required around 5 flights to cover the area.
