A.Spickermann (1), J.-P. Malet (1), Th.W.J. van Asch (2), M.C.G. van Maarseveen (2), D.B. van Dam (2) and H. Markies (2)

INTRODUCTION

FLUME TESTS

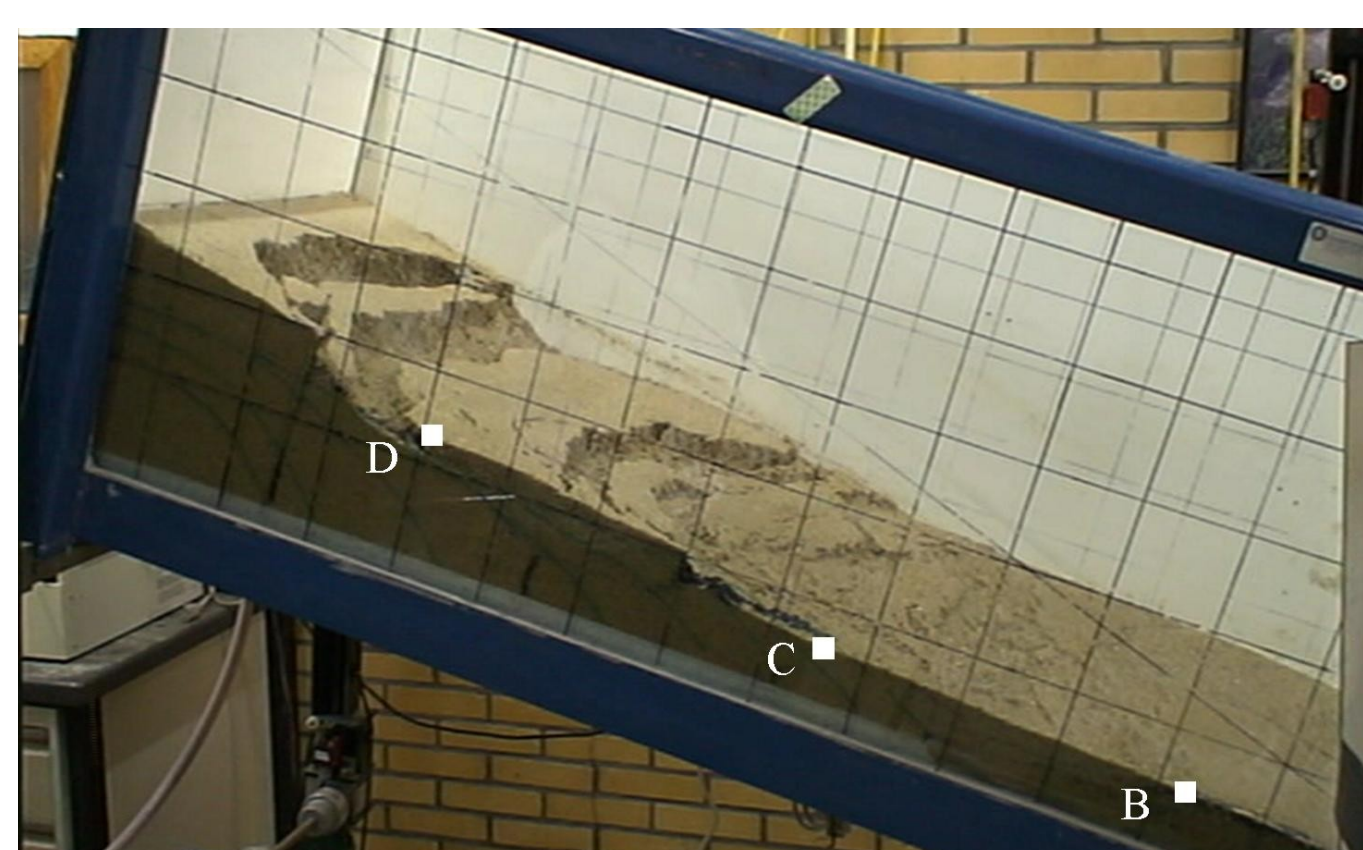
Fig. 3: Final phase of retrogressive failure (12:05:49) inclusive observed points B, C, D.

To analyse the time displacement behaviour the movement of 4 points at the slope surface is measured (Figs. 2, 3, 4).

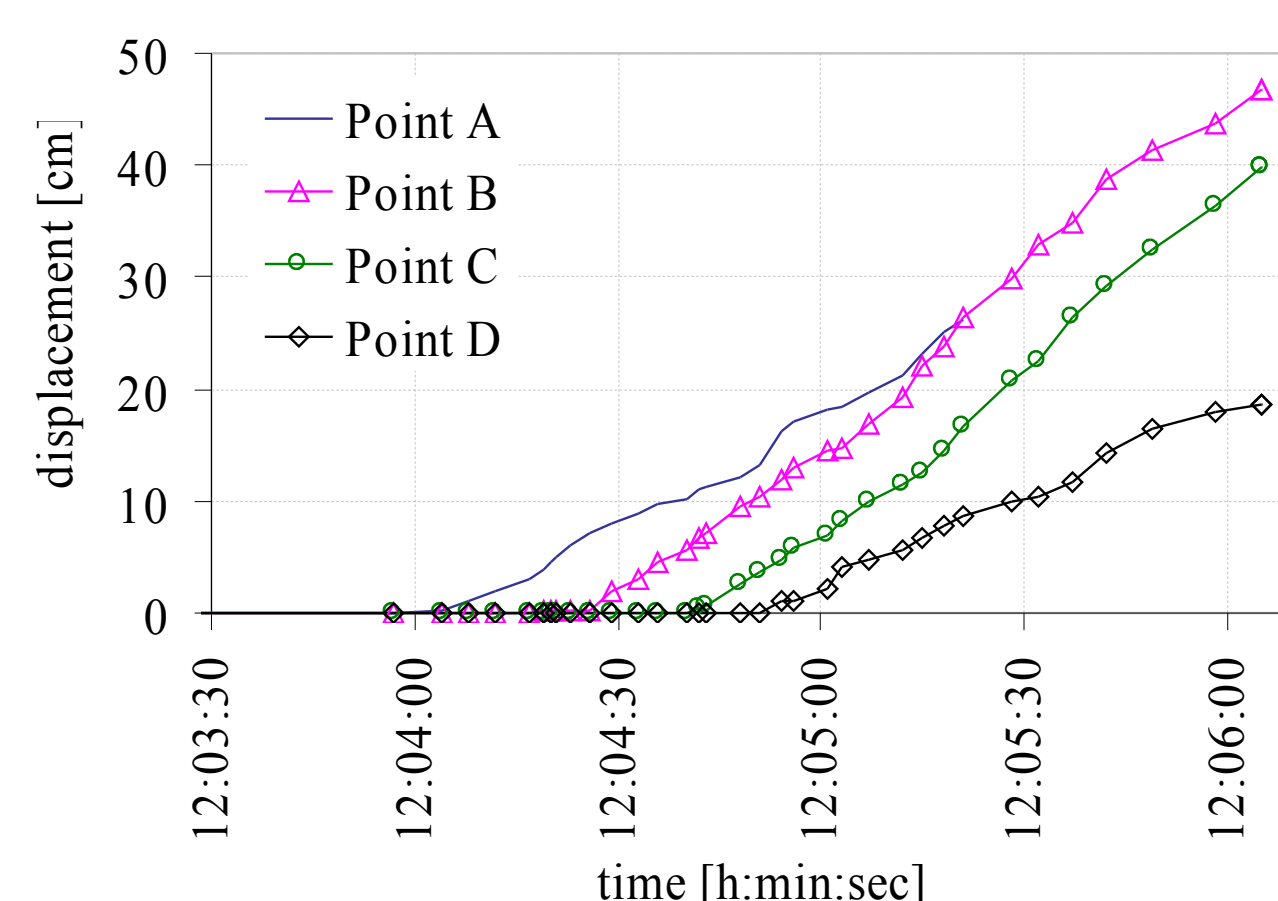
Fig. 4: Time displacement curves of points A, B, C, D at the slope surface (the ending points of the graphs are limited because of observation reasons, it does not mean that the soil mass stops to move).

After about 15 min of water supply failure starts at the toe (point A) and it continues in direction of the crest. In Figure 5 the geometry and sequence of slumps are displayed and Figure 6 gives the development of slumps in time. It is assumed that due to liquefaction of the soil at the toe a first slip surface (slump 1) is formed.

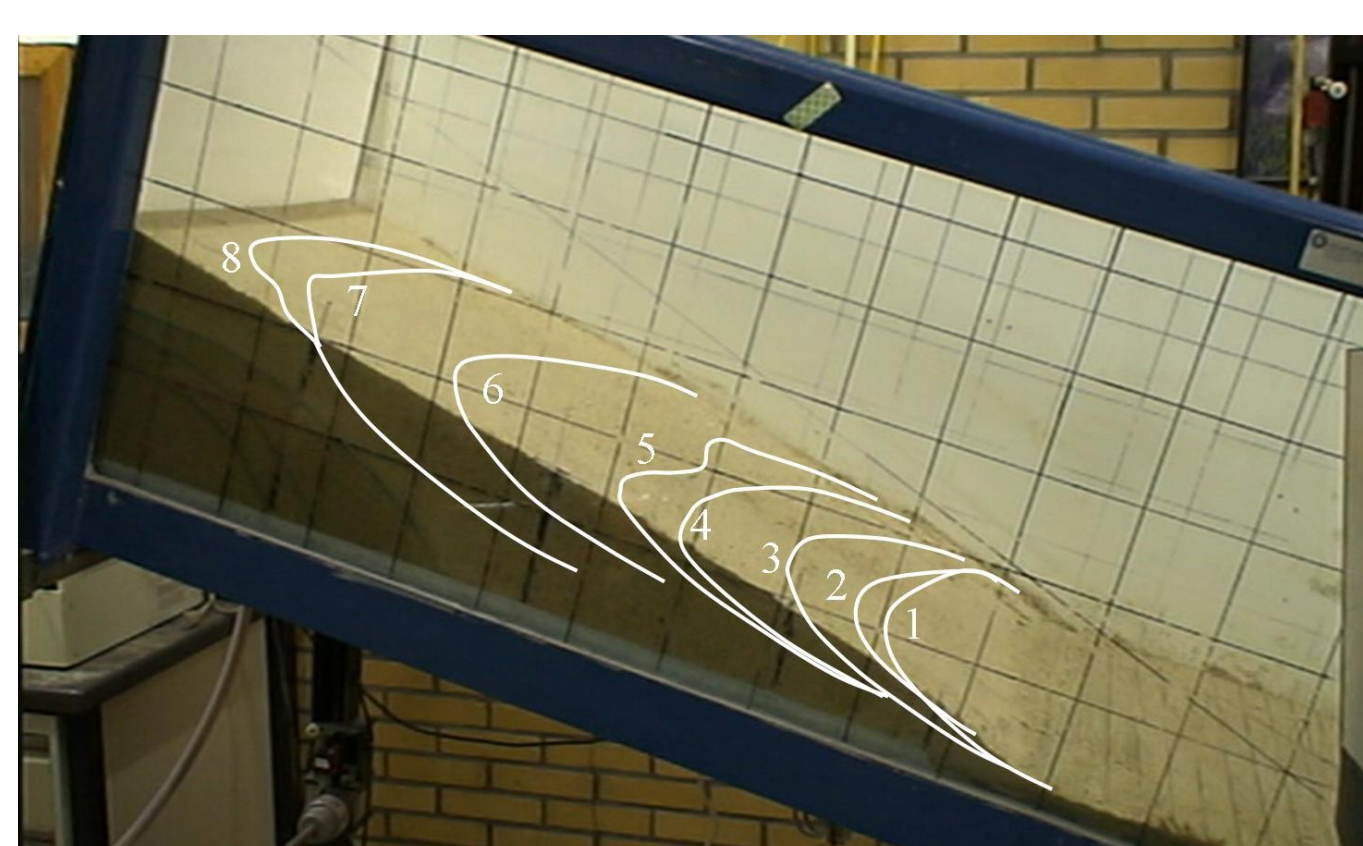
Fig. 5: Geometry and sequence of slumps during retrogressive failure.

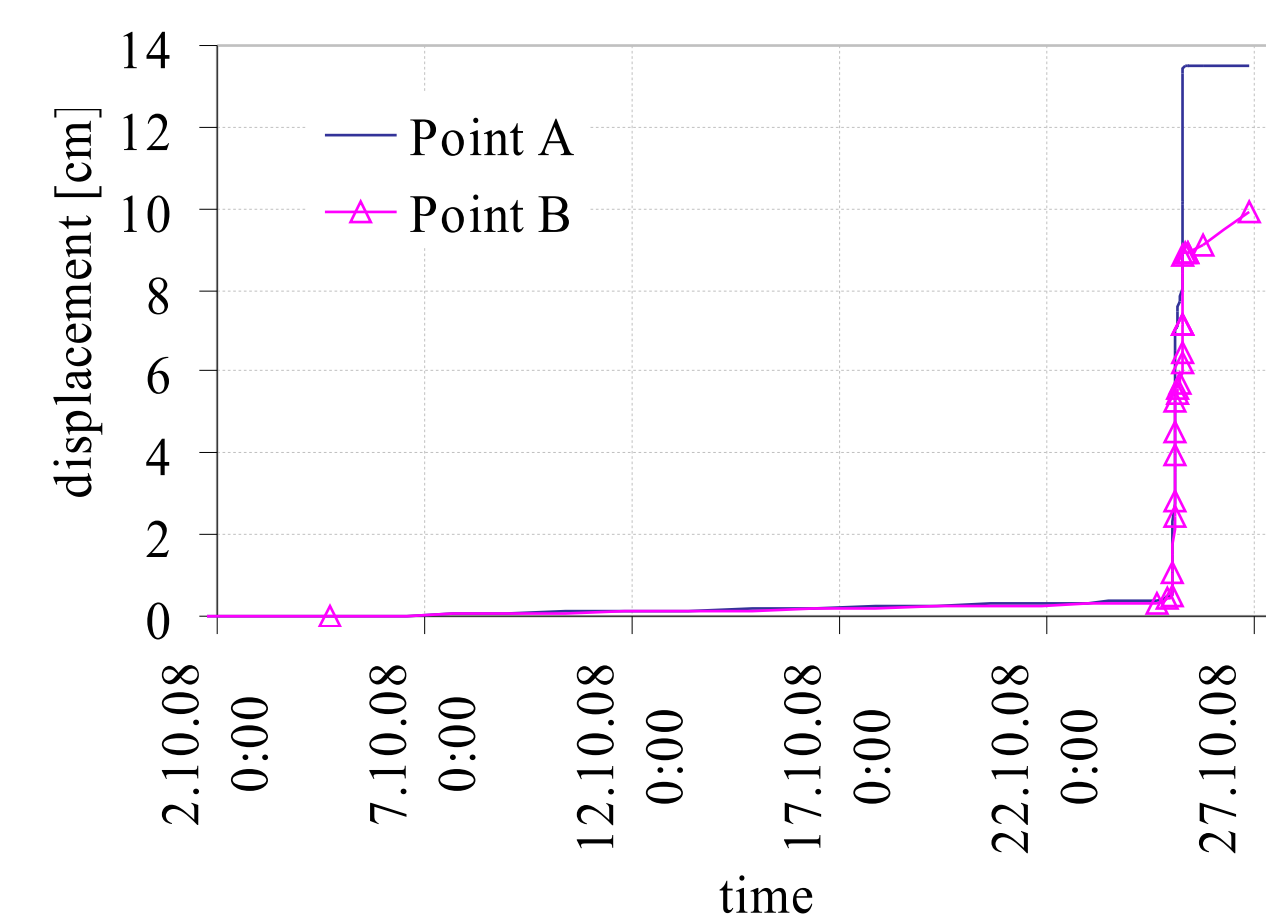
Fig. 8: Time displacement curves of points A, B at the slope surface.

The displacements in time are measured using two points at the slope surface (Figs. 7, 8, 9, 10). Figure 8 presents the time displacement curves of the whole failure process (25 days). The curve can be divided into two parts, where the first part is characterized by a very slow movement that took place from 01-10-2008 until 24-10-2008. In the second part the movement velocity increases and final failure occurs. In Figure 9 the second phase of the time displacement behaviour is illustrated in detail.

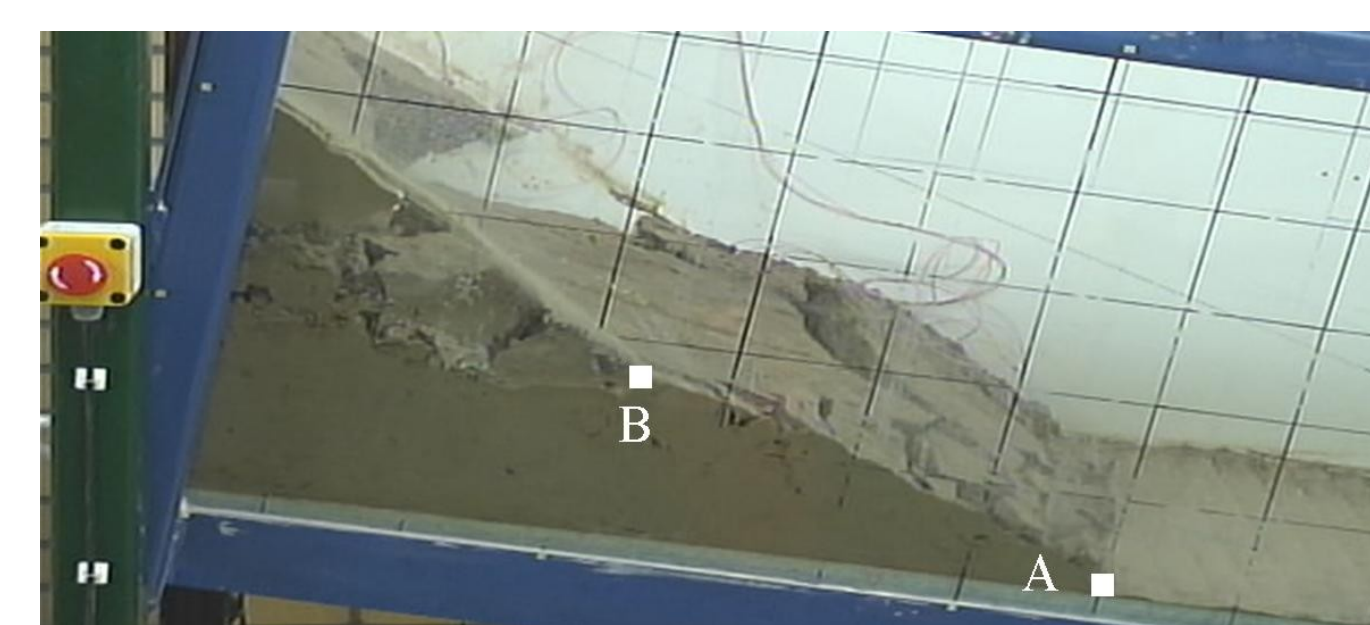
Fig. 10: Slope after failure, 26-10-2008, inclusive final positions of observed points A, B.

The first part of the failure process is characterised by the development of fissures and cracks. Final failure occurs within one slump in two stages. The whole process is characterised as progressive failure that is typical for cohesive materials.
